New Apollo Schedule Awaits End of Probe

Apollo 204 Review Board

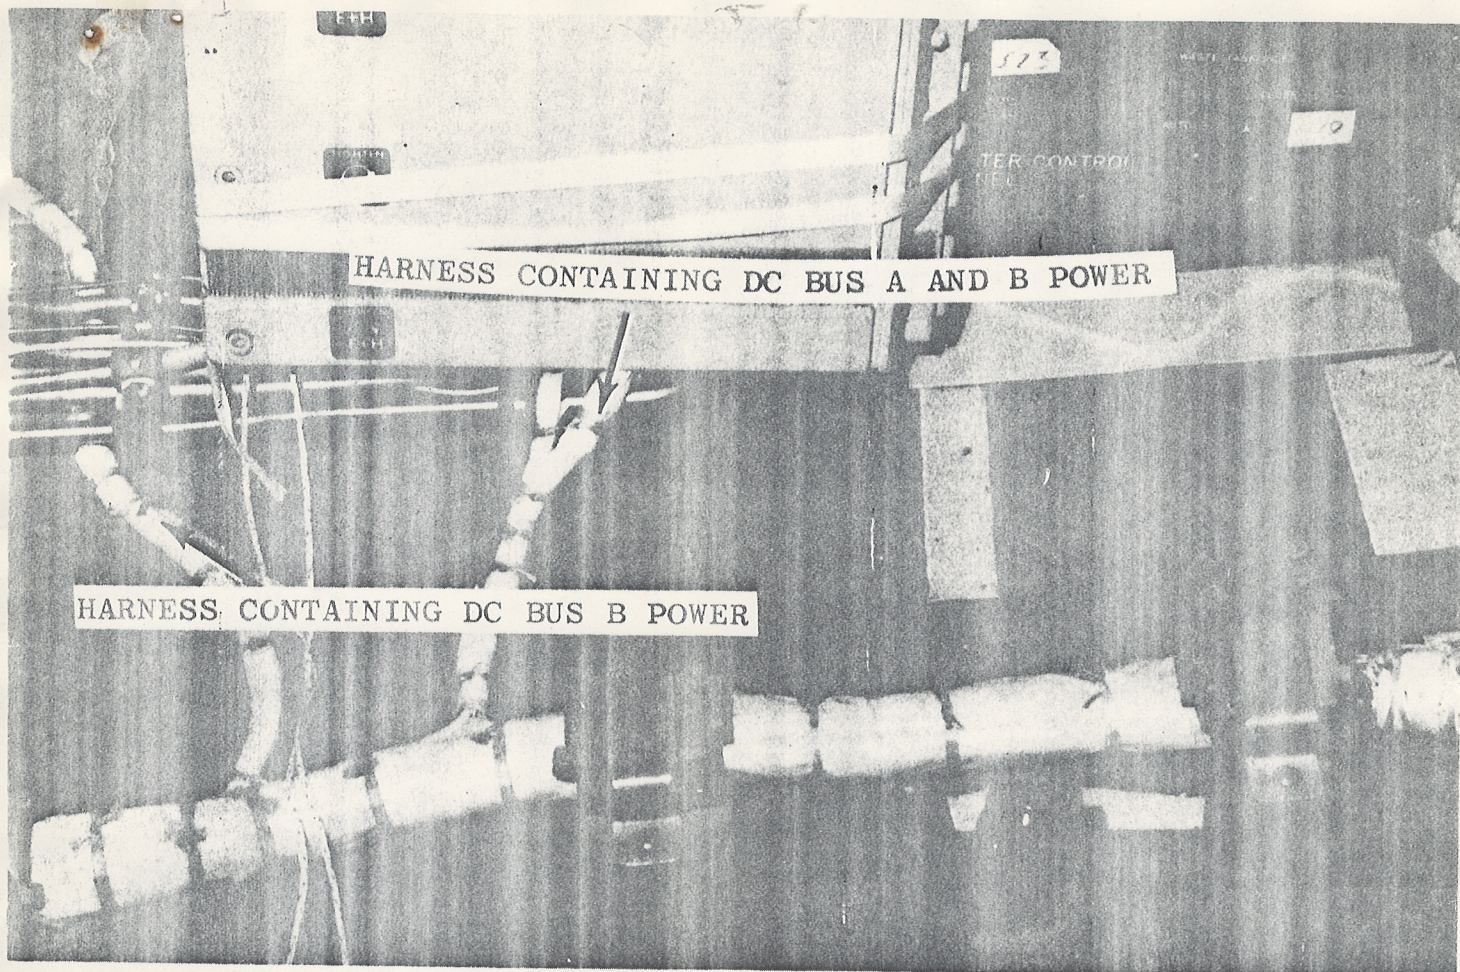
Apollo Review Board determined that this area near the floor in the lower forward section of the left-hand equipment bay below the Environmental Control Unit was the most probable

initiator of the fire in the spacecraft. DC power cable is shown crossing over aluminum tubing and under lithium hydroxide access door in spacecraft 014 used in the investigation.

Myers said that the fact that the wire bundle, which is supposed to have a ¼-in. clearance under the door, actually touched the door in spacecraft 014 has complicated the issue considerably.

However, spacecraft 014—the duplicate rushed to the Cape after the fire for comparison—had not gone through a final checkout during which this bundle would have been tamped down, he said. Therefore, it did not represent the true state of affairs for spacecraft 012.

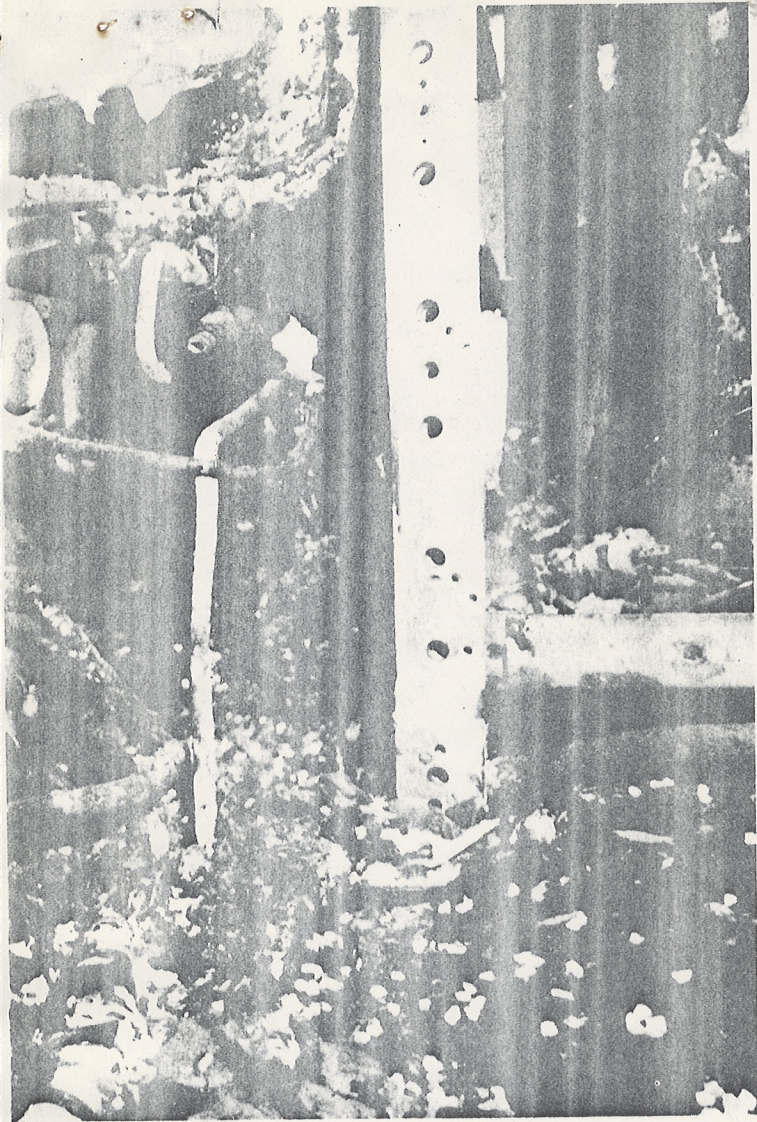
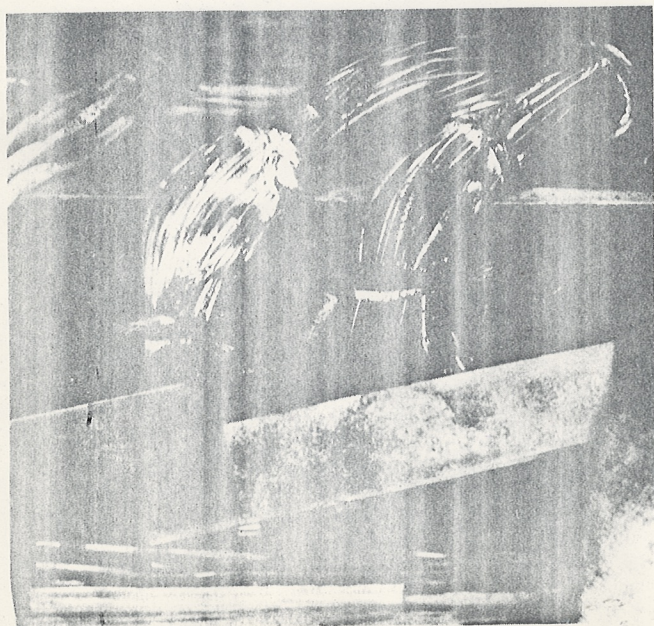
ABOVE: Charred area in spacecraft 012 (essentially the same area shown on page 17) is believed to be the most likely region for the start of the fire. Probable cause is an electrical arc in a power cable. BELOW: View of burned cable.

The most probable initiator was an electrical arc in the sector between the $-Y$ and $+Z$ spacecraft axes. The exact location best fitting the total available information is near the floor in the lower forward section of the left-hand equipment bay where Environmental Control System (ECS) instrumentation power wiring leads into the area between the Environmental Control Unit (ECU) and the oxygen panel. No evidence was discovered that suggested sabotage.
