New Apollo Schedule Awaits End of Probe

Apollo 204 Review Board

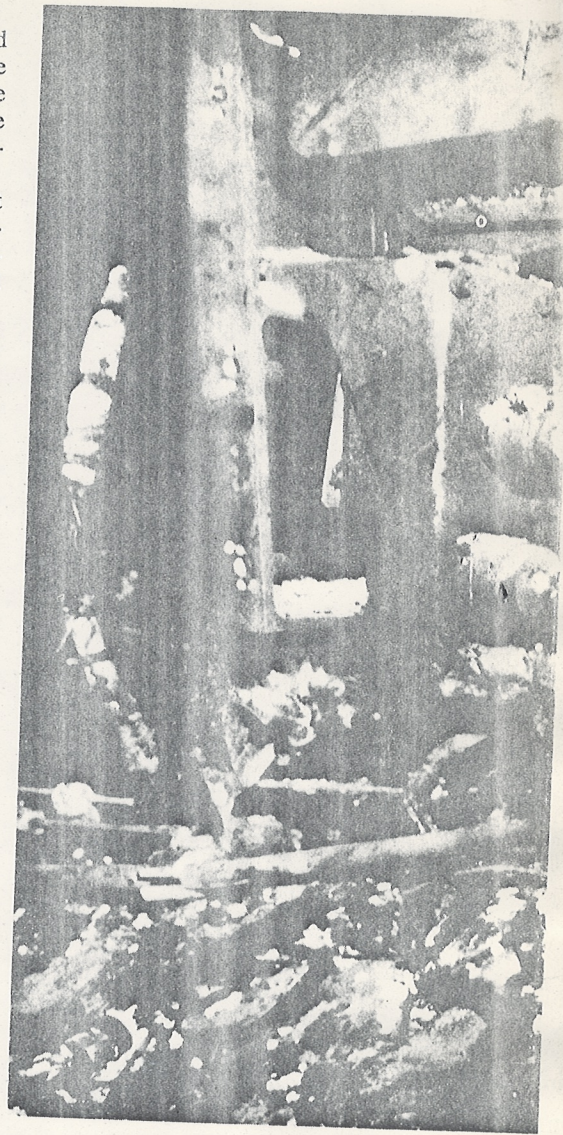
Suspect wires—NAA engineers do not feel that the Teflon-coated wire bundle, which passes under the door leading to the lithium hydroxide panel, was the source of the electric arc that apparently caused the fire. While the investigating board does not specifically name this as the cause, it has pinpointed this area as the source of the fire, leading to speculation that chafing from the door might have removed some of the insulation.

ABOVE: Charred area in spacecraft 012 (essentially the same area shown on page 17) is believed to be the most likely region for the start of the fire. Probable cause is an electrical arc in a power cable. BELOW: View of burned cable.
